Maintenance Management In Handling The Problem of Rail Damage Affecting Railway Travel Safety (Wonokromo-Sidoarjo Route)

As happened on the Wonokromo-Sidoarjo crossing, which is a Rail that connects between Wonokromo Station and Sidoarjo Station at Daop VIII Surabaya. Based on data from the Railway Engineering Center class 1 of the Eastern Java Region, the length of the Wonokromo – Sidoarjo crossing is 17,629 km, of which there are 4 active stations and 1 inactive station, namely from Wonokromo Station, Waru Station, Gedangan Station, Buduran Station, and Sidoarjo Station (ERSAN, 2019). This line is passed by local trains, commuter lines and express trains (long distance), and freight trains. Some of the trains that pass on the Wonokromo Station to Sidoarjo Station line are Mutiara Timur Train to Banyuwangi, Jayabaya Train from Malang to Jakarta via Surabaya Gubeng Station, Ranggajati Train to Jember, Sri Tanjung Train to Banyuwangi, Penataran Train to Malang, Surabaya Porong Komuter Train to Surabaya-Porong (pp), Freight Train (BBM) from Surabaya-Malang (pp), and Logawa Train to Jember. There is a special train stop that is reserved only for Delta Express Train (Komuter Train) (H

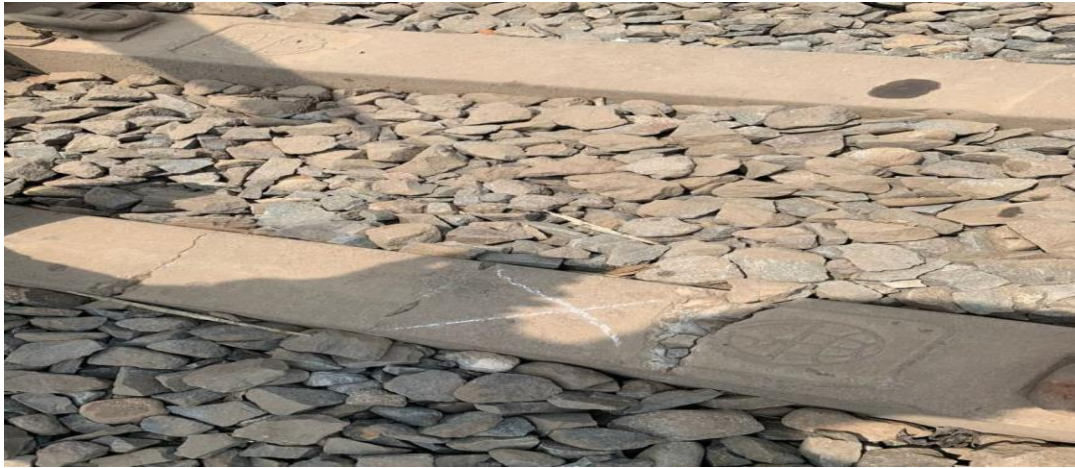
From the results of the survey conducted during the field research, there was damage to the bearing at KM 21 + 657. And according to PM 32 of 2011 concerning Standards and Procedures for Railway Infrastructure Maintenance, it is stated that bearings that experience cracks are categorized into the C (light) classification which means that they are still classified as safe because they do not interfere with train travel and the distance between the average bearings on the Wonokromo - Sidoarjo crossing which was found at that time was 45 cm to 58 cm long. Seen in **Picture 4,2**

Figure 2 Broken Bearing

After analyzing the damage to this bearing, it turns out that it is influenced by material factors, namely the existence of less reaction conditions, and geometric factors (such as unstable soil quality) also have an effect. But if the damage has been included in the A (heavy) classification, then the bearing must be replaced immediately because it will interfere and endanger the train journey that will pass through the line.

The solution is to maintain the bearing function according to the design that has been set. The scope for performing maintenance on rail bearings is:

- a. Checking the condition of the bearing;
- b. Checking the distance between the bearings;
- c. Replacing damaged bearings.

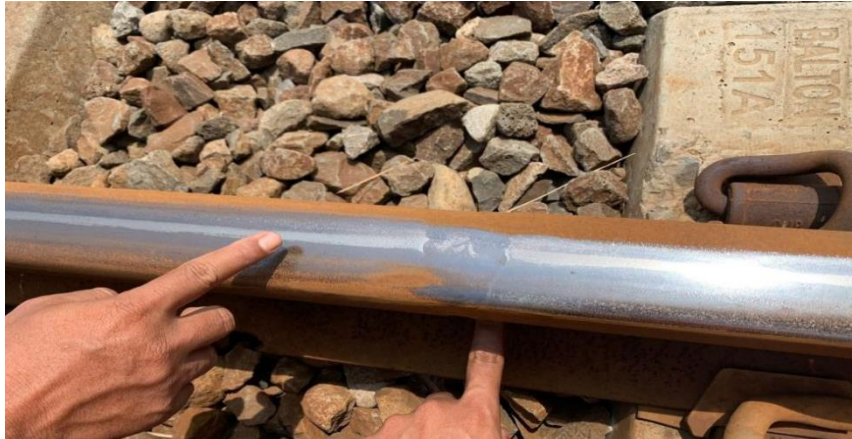
Figure 4 Rail Defect

On the Wonokromo – Sidoarjo crossing, the type of rail type R.42 is used, on the crossing there are *defective rails* or worn rails. *Rail defects occur due to friction between the wheels of the train that is too fast, causing a depression in the rail body. In addition, due to the existence of this rail defect, there is discomfort felt by passengers when the train passes on the track, namely a slight jolt.*

On the Wonokromo – Sidoarjo crossing using the R.42 rail type and all *rail defects* can still be tolerated.

- a. Visually check and measure the wear of the rails.
- b. Perform welding if the wear has exceeded the tolerance limit.

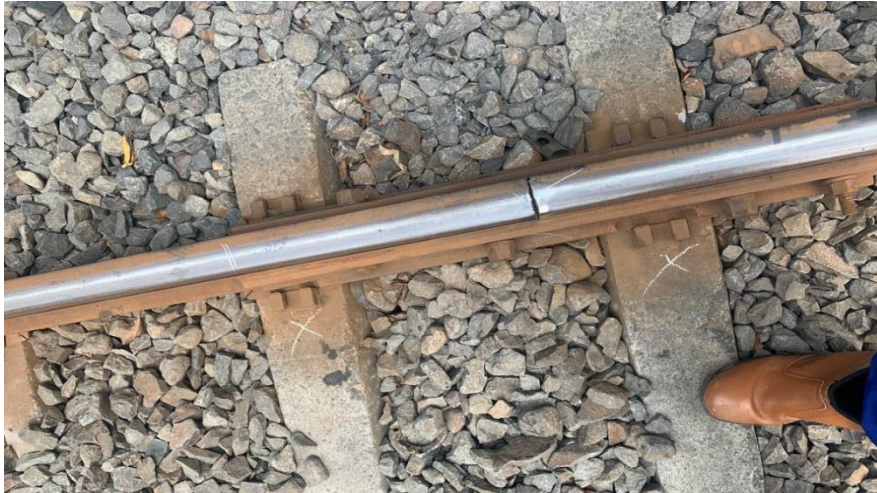
Figure 5 Missing Anchor

A very dangerous disturbance to the rail road is if the anchor is lost three times in a row. And causing the width of the rail to change and result in when the train runs at maximum speed, there will be a drop.

On the Wonokromo – Sidoarjo crossing, there are still many missing or incomplete anchors, it is caused by the clamp nails that are cushioned in a loose state so that if the train passes at maximum speed there will be vibrations that result in the anchor coming off.

- a. Visual checking;
- b. Check the strength of the swaying anchor and tighten it for the rigid anchor type, and replace the elastic anchor

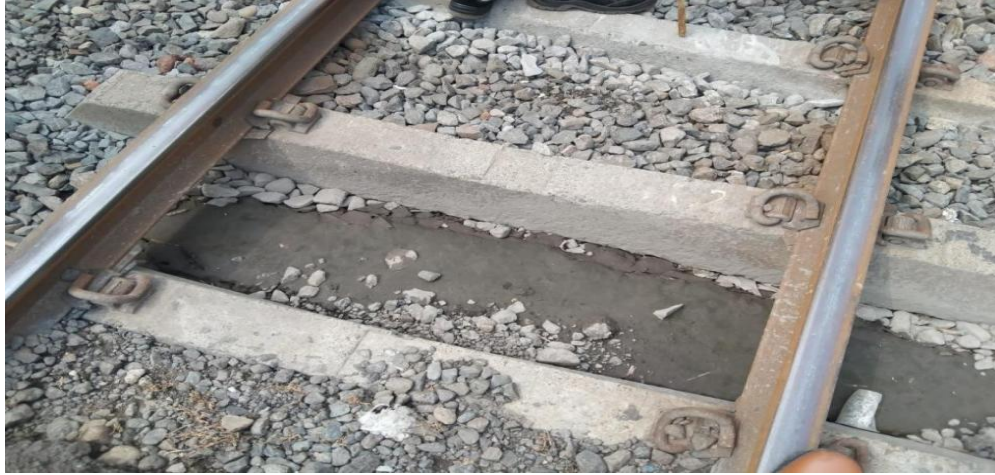
Figure 6 Mud Pumping

Mud pumping (stuck) is caused by a poor functioning of the drainage system which results in the flow of water when it rains cannot decompose properly, so that water settles under the bearing. If this happens and continues to be left unchecked, it will cause the bearing to not function perfectly. With that, drainage maintenance is carried out to keep the flow of water from interfering with train operations. The scope of drainage treatment includes:

a. Check the slope of drainage;

b. Check the condition of drainage flow;

c. Checking the condition of drainage buildings;

d Repair of drainage channels.

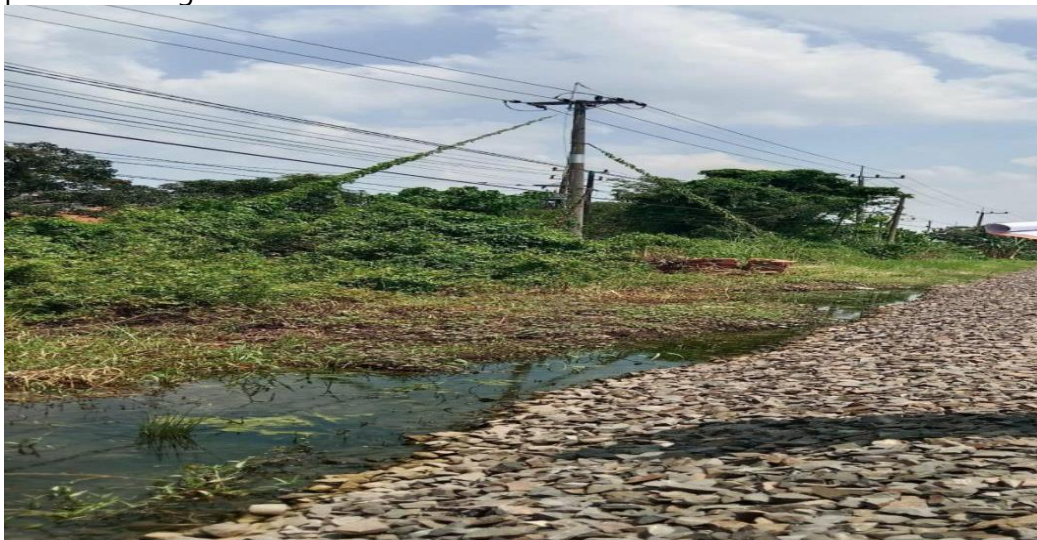
Figure 7. Drainage

In the picture above, it can be seen that the drainage system is still very poor, when it rains, the area will experience flooding that almost covers the rail road on the right side.

- a. Reactivation of drainage that is no longer functioning;
- b. Cleaning sewers clogged with garbage or grass growing around the drainage;
- c. Rehabilitation of drainage channels.

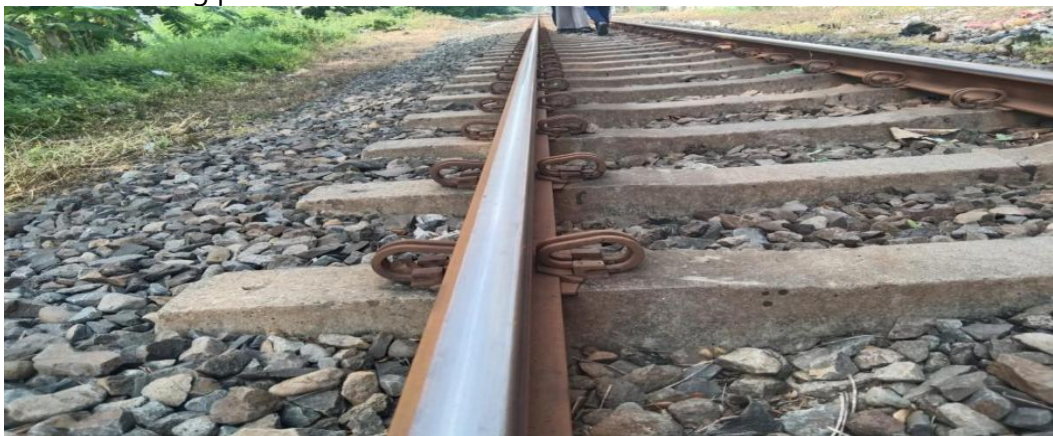
Underreply is one of the rail road disturbances caused by the absence of a stopper reply that functions to hold back the backlash so that it does not scatter when receiving vibrations when the train passes. On the Wonokromo-Sidoarjo crossing, there is still a rail road disruption, namely a low volume of feedback. This is clearly seen in the picture of the condition of the rail road in the following picture:

Figure 8 Volume Reply Less
