REHABILITATION METHODS OF RASUNA SAID HOUSE IN AGAM REGENCY, WEST SUMATRA

1. Methods of Rehabilitation of Rasuna Said's House The planning for the rehabilitation of Rasuna Said's house was made based on the results of previous research, where one of the recommendations from the research results was to make a method for the rehabilitation or maintenance of Rasuna Said's house as a Cultural Heritage Building. The following will explain the method of

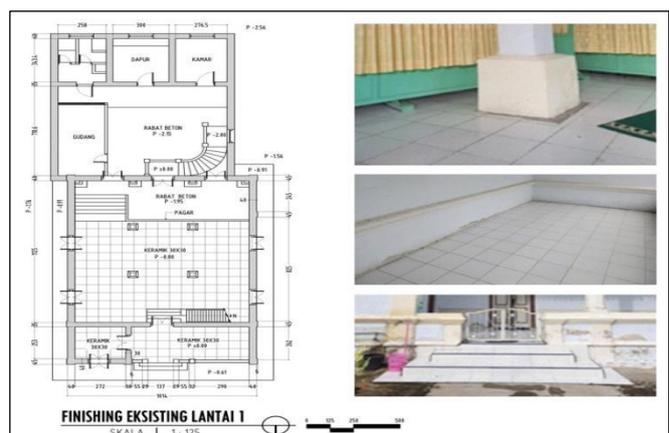
The first floor of the house will be returned to its original position, namely the stage-shaped floor is under the floor. For the first floor, the material will also be returned by reinstalling the wooden floor. Because the current condition of the floor is to use a ceramic floor that has been changed from the shape and material of the floor when the building was first built. To restore the condition of the floor to its original shape, it is done by raising the middle floor so that it is parallel to the floor at the front. The position of the floor beams is right above the rectangular foundation that protrudes above the tiled floor now. Installation of wooden floors by not dismantling the existing ceramic floors. The floor framework uses wood with good quality, no defects and selected wood in a completely dry condition. Before installing all wooden frames must be sprayed against termites. The condition of the floor is now as shown in Figure 1.

Figure 1. Existing condition of the 1st floor.

The method of working on the 1st floor, namely the wooden floor framework is installed on an existing foundation with a
