Maintenance Management In Handling The Problem of Rail Damage Affecting Railway Travel Safety (Wonokromo-Sidoarjo Route)

As happened on the Wonokromo-Sidoarjo crossing, which is a Rail that connects between Wonokromo Station and Sidoarjo Station at Daop VIII Surabaya. Based on data from the Railway Engineering Center class 1 of the Eastern Java Region, the length of the Wonokromo – Sidoarjo crossing is 17,629 km, of which there are 4 active stations and 1 inactive station, namely from Wonokromo Station, Waru Station, Gedangan Station, Buduran Station, and Sidoarjo Station (ERSAN, 2019). This line is passed by local trains, commuter lines and express trains (long distance), and freight trains. Some of the trains that pass on the Wonokromo Station to Sidoarjo Station line are Mutiara Timur Train to Banyuwangi, Jayabaya Train from Malang to Jakarta via Surabaya Gubeng Station, Ranggajati Train to Jember, Sri Tanjung Train to Banyuwangi, Penataran Train to Malang, Surabaya Porong Komuter Train to Surabaya-Porong (pp), Freight Train (BBM) from Surabaya-Malang (pp), and Logawa Train to Jember. There is a special train stop that is reserved only for Delta Express Train (Komuter Train) (H

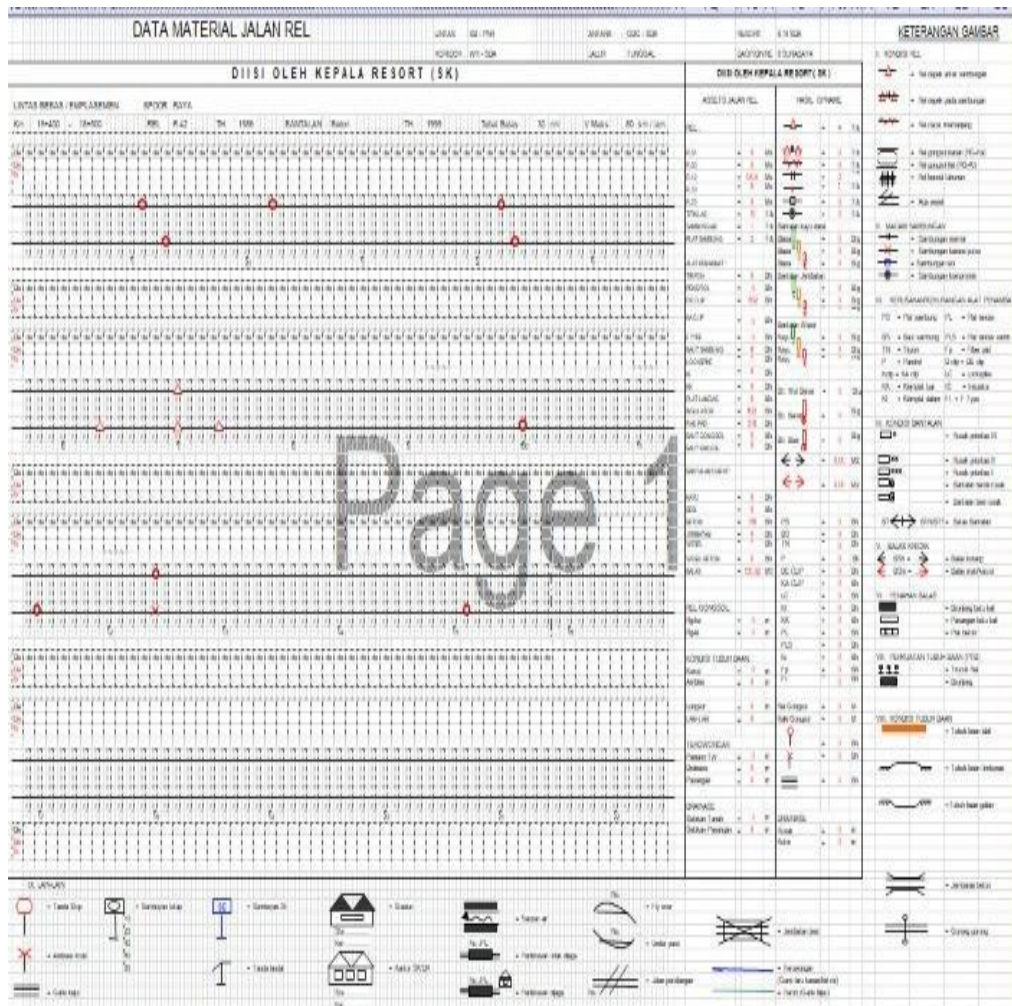
Figure 1 DMJR Sheet (Rail Road Material Data)
Source : Sidoarjo Road and Bridge Resort, 2023

On the rail road on the Wonokromo – Sidoarjo crossing, there are disturbances such as missing anchors, *rail defects*, and broken bearings. These disturbances, if left unchecked, will result in train travel traffic that passes on the Wonokromo – Sidoarjo crossing. In the results of the DMJR (Rail Road Material Data) survey carried out, several damage to the rail road along the Wonokromo – Sidoarjo crossing was found, as follows:

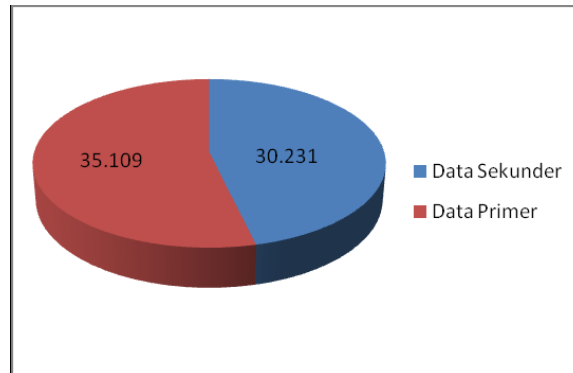
Figure 3 Comparison of the number of bearings

So if we look at the calculation above which is in accordance with the standard, the results of 29,382 bearings along the Wonokromo to Sidoarjo crossing are obtained, but in the results of the Rail Road Material Data (DMJR) carried out there are 35,109 bearings. So if you look for the cause of the number of bearings more than the standard number:

- 1) due to the inappropriate distance between the pads, which is 60 cm,
- 2) Because the attached anchor is not tight or loose.

Therefore, why on the Wonokromo – Sidoarjo crossing, especially after the Gedangan station at kilometers 18 + 100 – 18 + 200, the number of bearings at the kilometer amounts to 189 bearings which should be the number of bearings per meter, which should be 166 – 167 bearings. Because the distance between the bearings is not in accordance with the standard and also at the kilometer there are many anchors that are shaky or not tight which causes the bearings to shift every time the train passes.

- a. Conduct periodic checks on shaky anchors and tighten anchors or replace anchors;
- b. Measure each distance between the bearings in accordance with the standard of 60 cm, replace the damaged bearing immediately;
- c. Ensure sufficient supply of bearings.
