ANALYSIS OF FUNCTION IMPROVEMENTS DUE TO CHANGES IN CORE ZONE MATERIAL BASED ON VALUE ENGINEERING AT URUGAN BATU DAM

Tamblang Dam is one of the dams in Indonesia located in Bali Province and a rock urugan dam type with an upright core that has a dam peak elevation located on El. +185 m with a peak length of 260 m, and

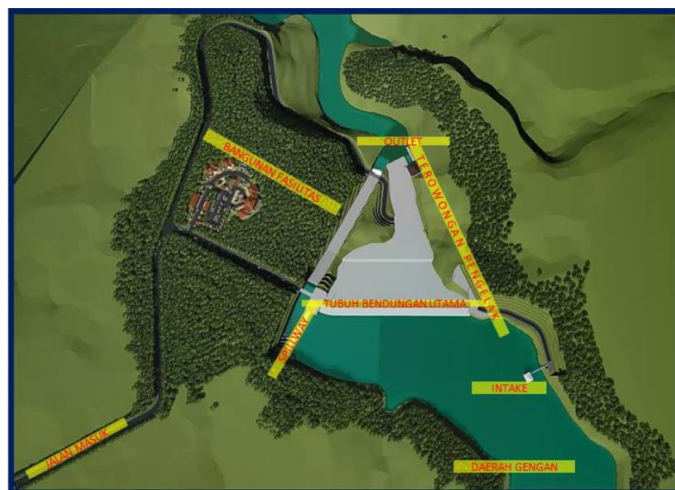
An overview of the layout of the Tamblang dam consisting of the main dam body,

evasion tunnel, spillway, intake, and outlet can be seen in figure 4.3 below.

Figure 3. Tamblang Dam Layout

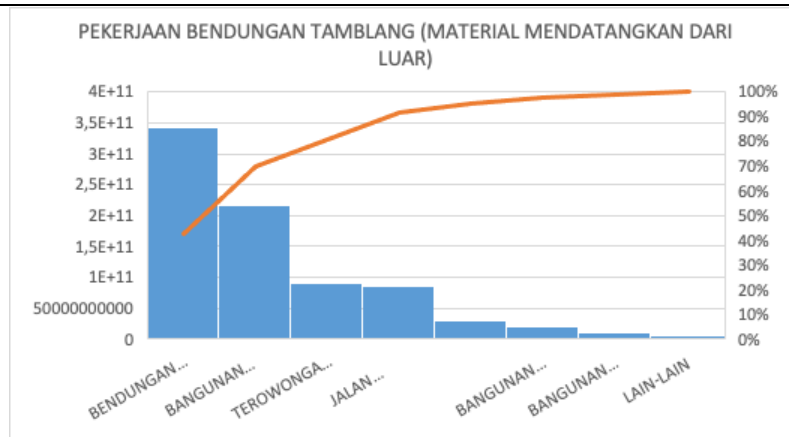
Figure 4. Overall Tamblang Dam Pareto Graph
(Source: Own Processed Products)

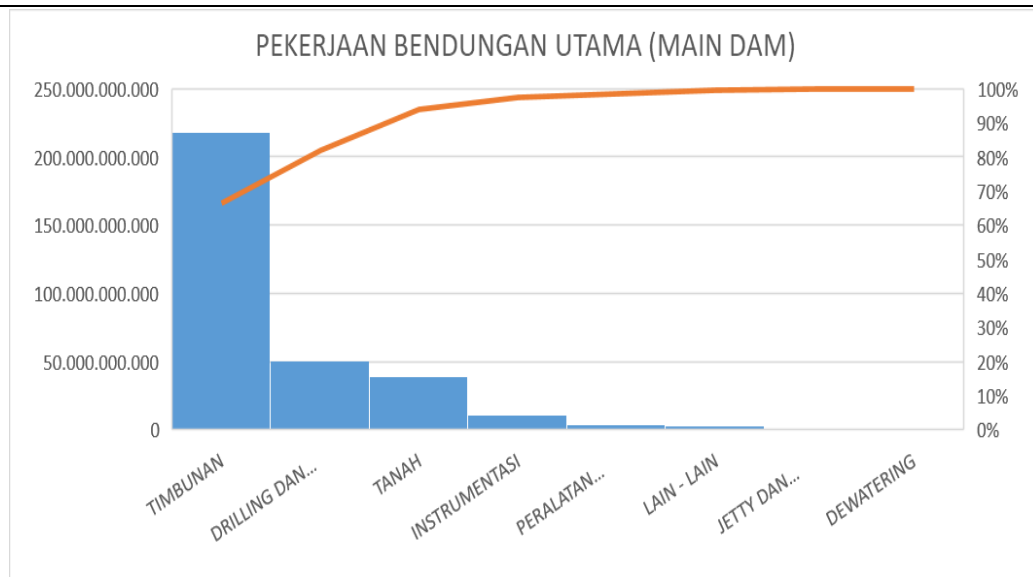
The following is the result of Pareto's analysis of the construction of the core zone of the Tamblang Dam, especially on

Figure 5. Main *Dam* Works Pareto Graph
(Source: Own Processed Products)
